Final Report: Malvern Hills AONB Hedgerow Survey 2009

Undertaken on behalf of the Malvern Hills AONB Partnership with funding from Defra

November 2009

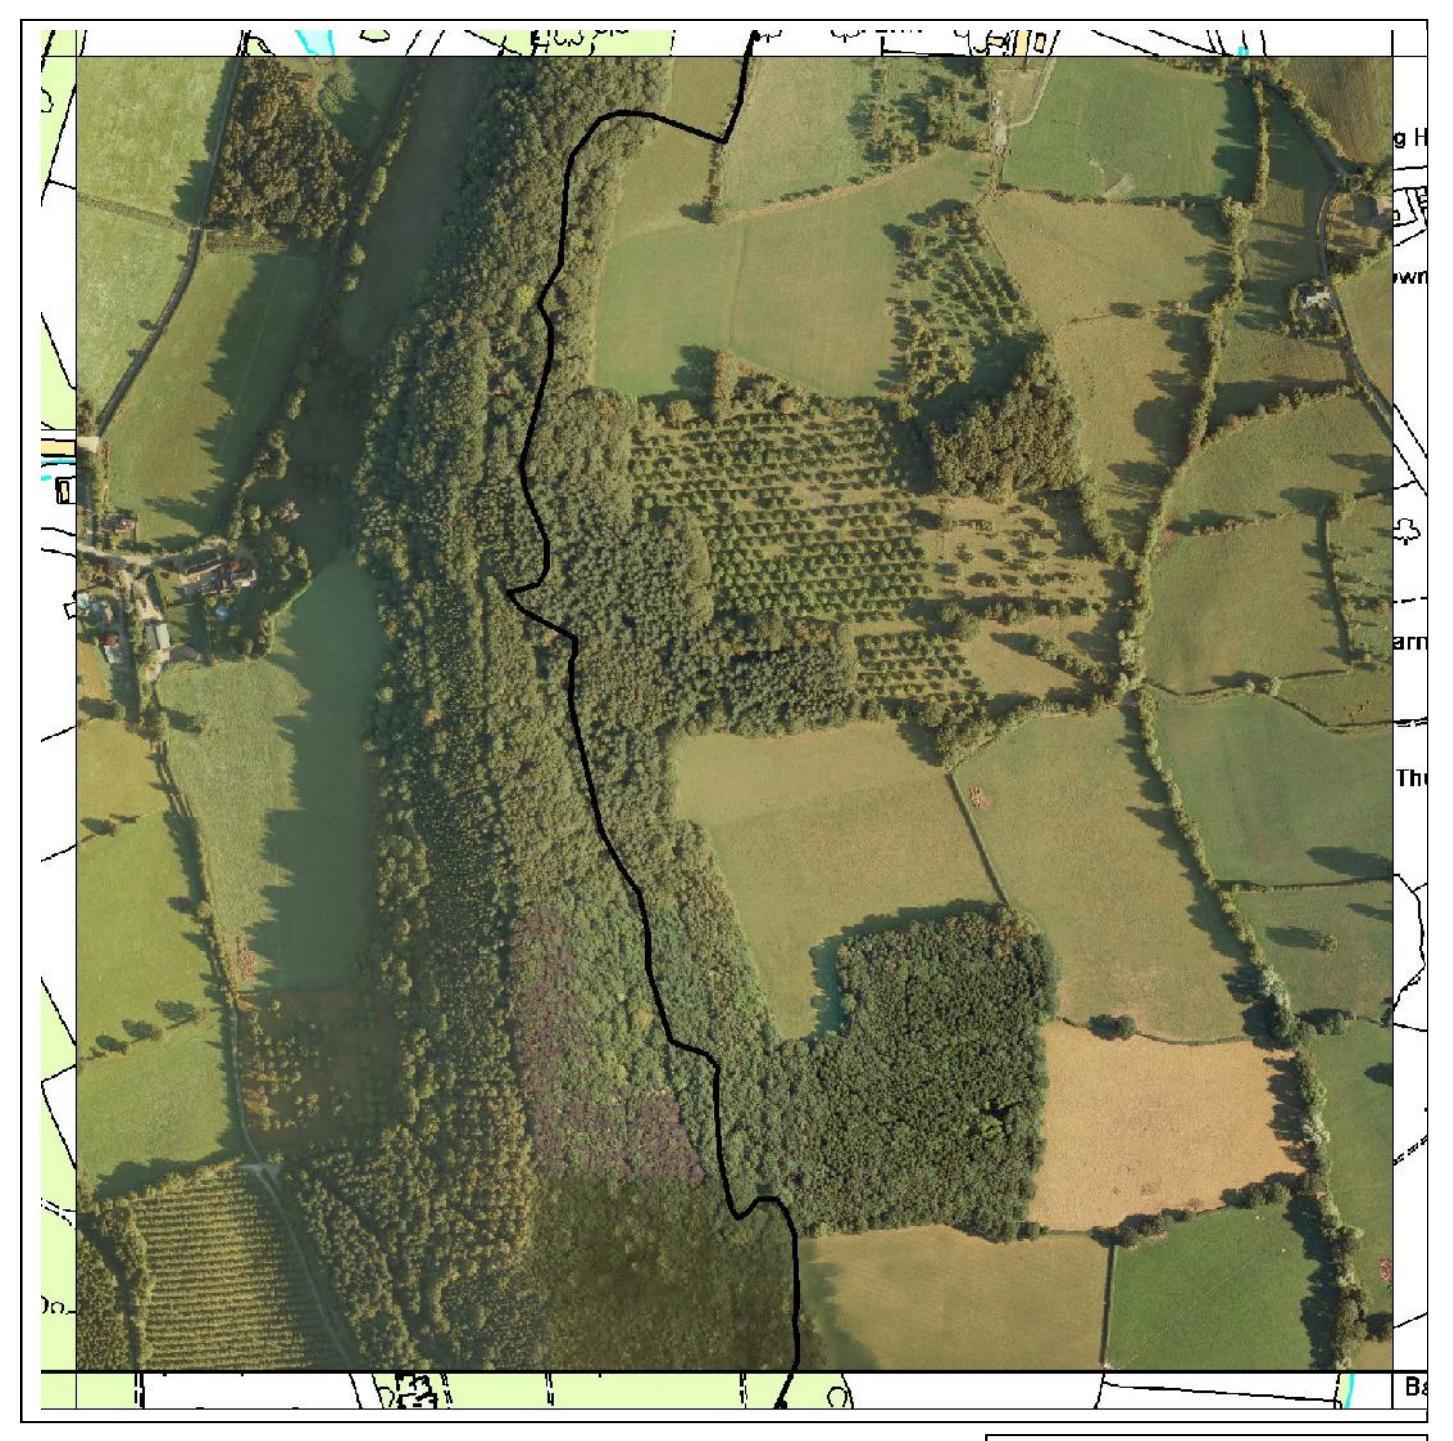
Figure 4. Alfrick Survey Square with aerial photograph overlaid on OS mapping

Summary of Landscape Character, Historic Landscape Character and Landscape Sensitivity (refer to Annex 1)	Summary of actual observations in survey square
Assarted pattern of woodland clearance overlaid with inserted pattern of piecemeal enclosure with semi-regular boundaries	Medium sized fields with sinuous assart-origin boundaries still evident but later, straight hedging additions prominent in places.
Mixed species hedgerows with hazel very prominent	The hedgerows in this area had the richest mix of woody species overall (16 recorded) than any other survey square. Hazel was present in 8 of the 9 hedges surveyed but was the dominent species in only one of those hedgerows. Hawthorn was the most consistently found species, being present in every hedgerow. Other frequently occuring species were dog rose and field maple. Other dominant species within individual hedges included english elm, blackthorn and dog rose.

Loss of organic field pattern in places	Insertion of straight boundaries was common, detracting from the sinuous organic hedgerow pattern
Locally poor age structure of hedgerow trees with most being mature or veteran	Trees abundant along watercourses but isolated hedgerow trees uncommon elsewhere. Four veteran oak pollards and one small-leaved lime coppice stool were recorded in the surveyed hedgerows. No young hedgerow trees were observed.
Neglected, unmanaged boundaries	Hedgerow management varied. Some hedgerows surveyed were fairly neatly managed, others were tall and mature.
Some hedge loss or fragmantation and occasional fencing additions	A small number of hedgerows had become gappy: these were now being restored under ELS. Some fencing sub-division of fields has taken place. Some hedge loss in preference to fences.

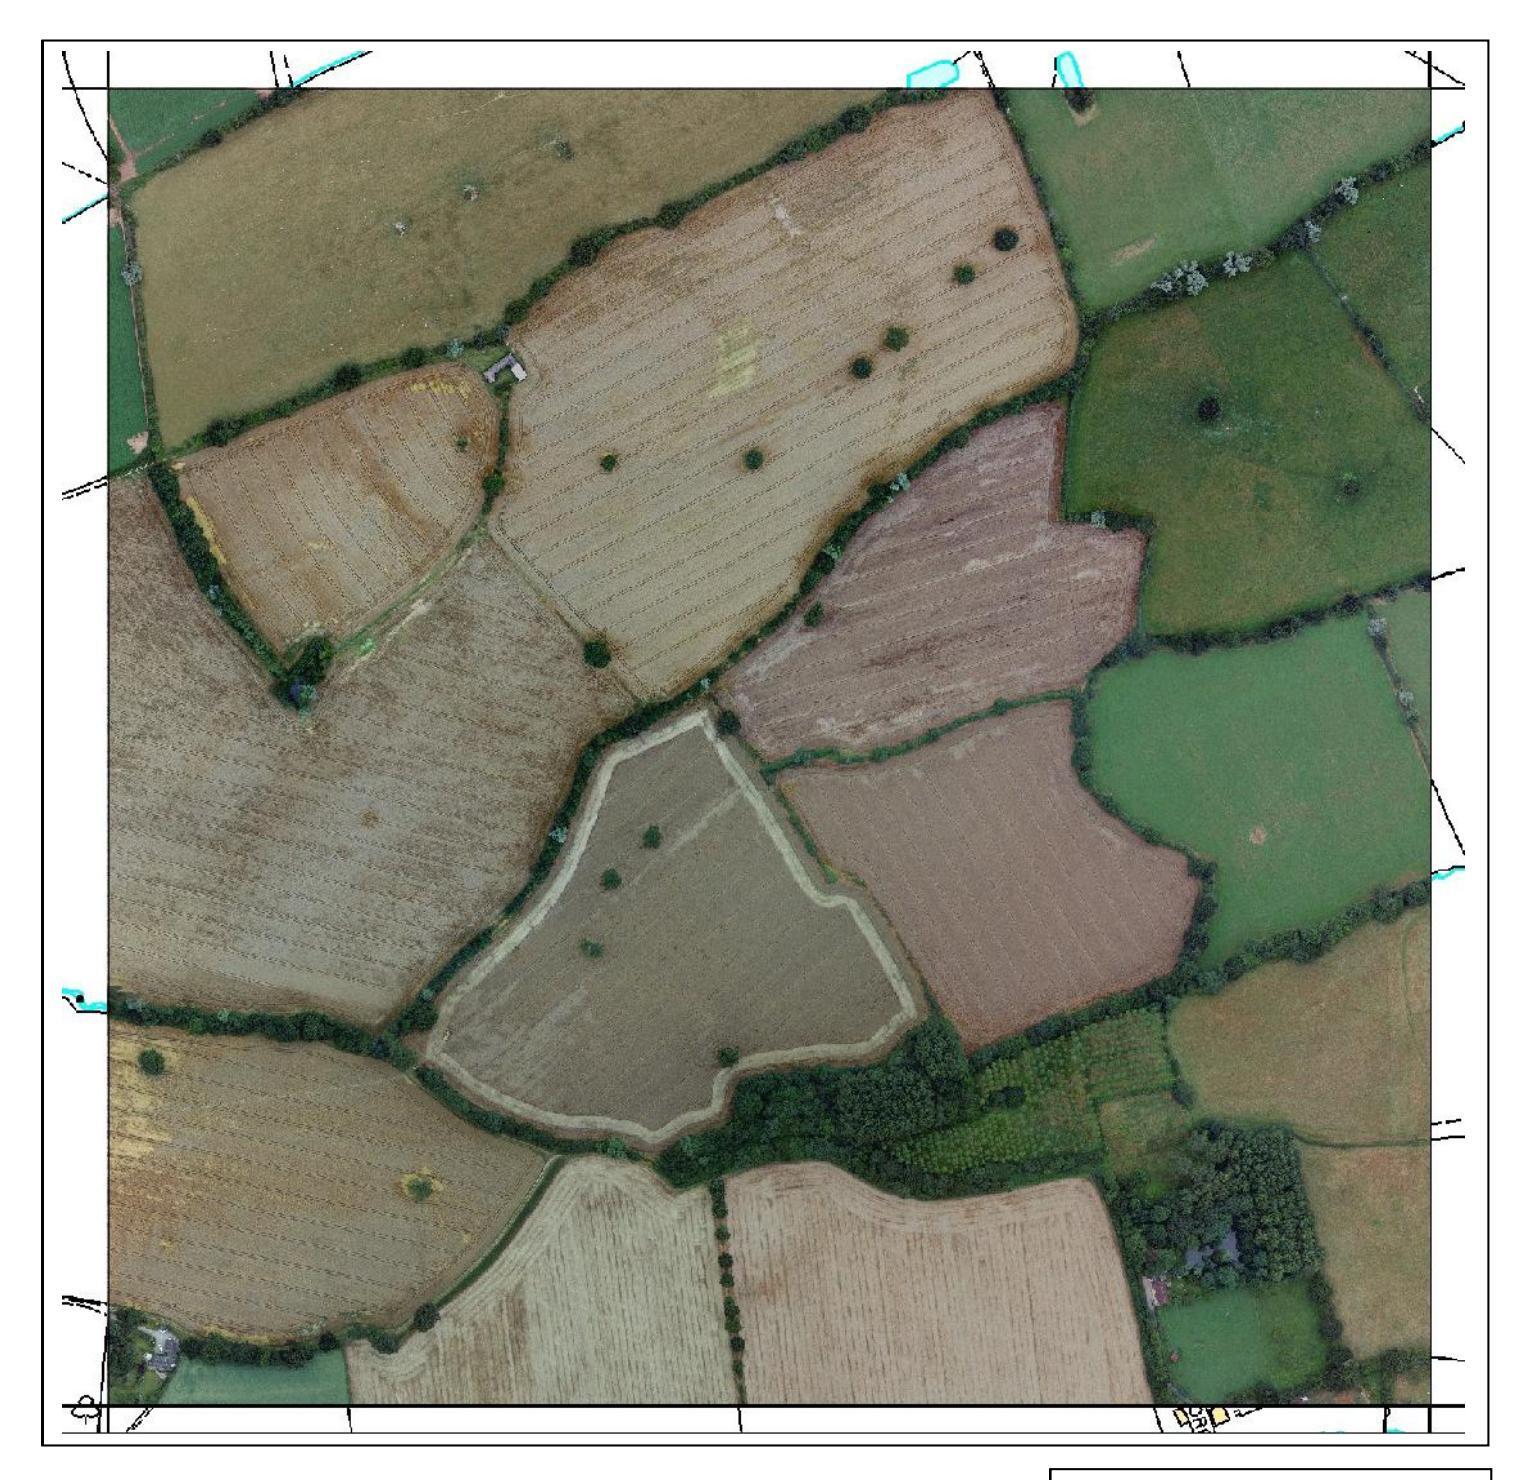
Figure 5. Colwall Survey Square with aerial photograph overlaid on OS mapping

Summary of Landscape Character, Historic Landscape Character and Landscape Sensitivity (refer to Annex 1)	Summary of actual observations in survey square
Small to medium scale organic pattern of hedged fields	Fields medium-large with sinuous, organic pattern of woodland-origin hedgerows still very evident.
Assarted pattern of woodland clearance	Sinuous and often wide hedgerow boundaries show woodland origins. Clearance of woodland for agriculture has been thorough leaving no ancient woodland blocks.
Hedgerow condition deteriorating in places	Many hedgerows are tall and mature. Some hedgerows situated in areas of permanent pasture are becoming gappy with soil erosion due to livestock damage. Occasional short sections of hedgerow have deteriorated and there was one fencing insertion.
Densely scattered hedgerow oaks with good species and age variation of trees	Scattered hedgerow oaks of varying sizes from 10cm to 100cm Diameter at Breast Height were recorded – the age variation here was better than that found in any other survey square. Other isolated hedgerow tree species recorded were hawthorn, field maple, alder, ash, willow, black poplar and white poplar. A sessile oak sapling (planted) was also noted.

Guidelines for the enhancement and protection of hedgerows within the Principal Timbered Farmlands Landscape Type that are of particular relevance in this grid square are to:

- Maintain the good age and native species diversity of hedgerow shrubs and trees
- Preserve the remaining enclosure patterns, resisting field amalgamation, replacement of hedgerows with fences and straightening of boundaries
- Restore hedgerow structure where neglect is leading to gaps

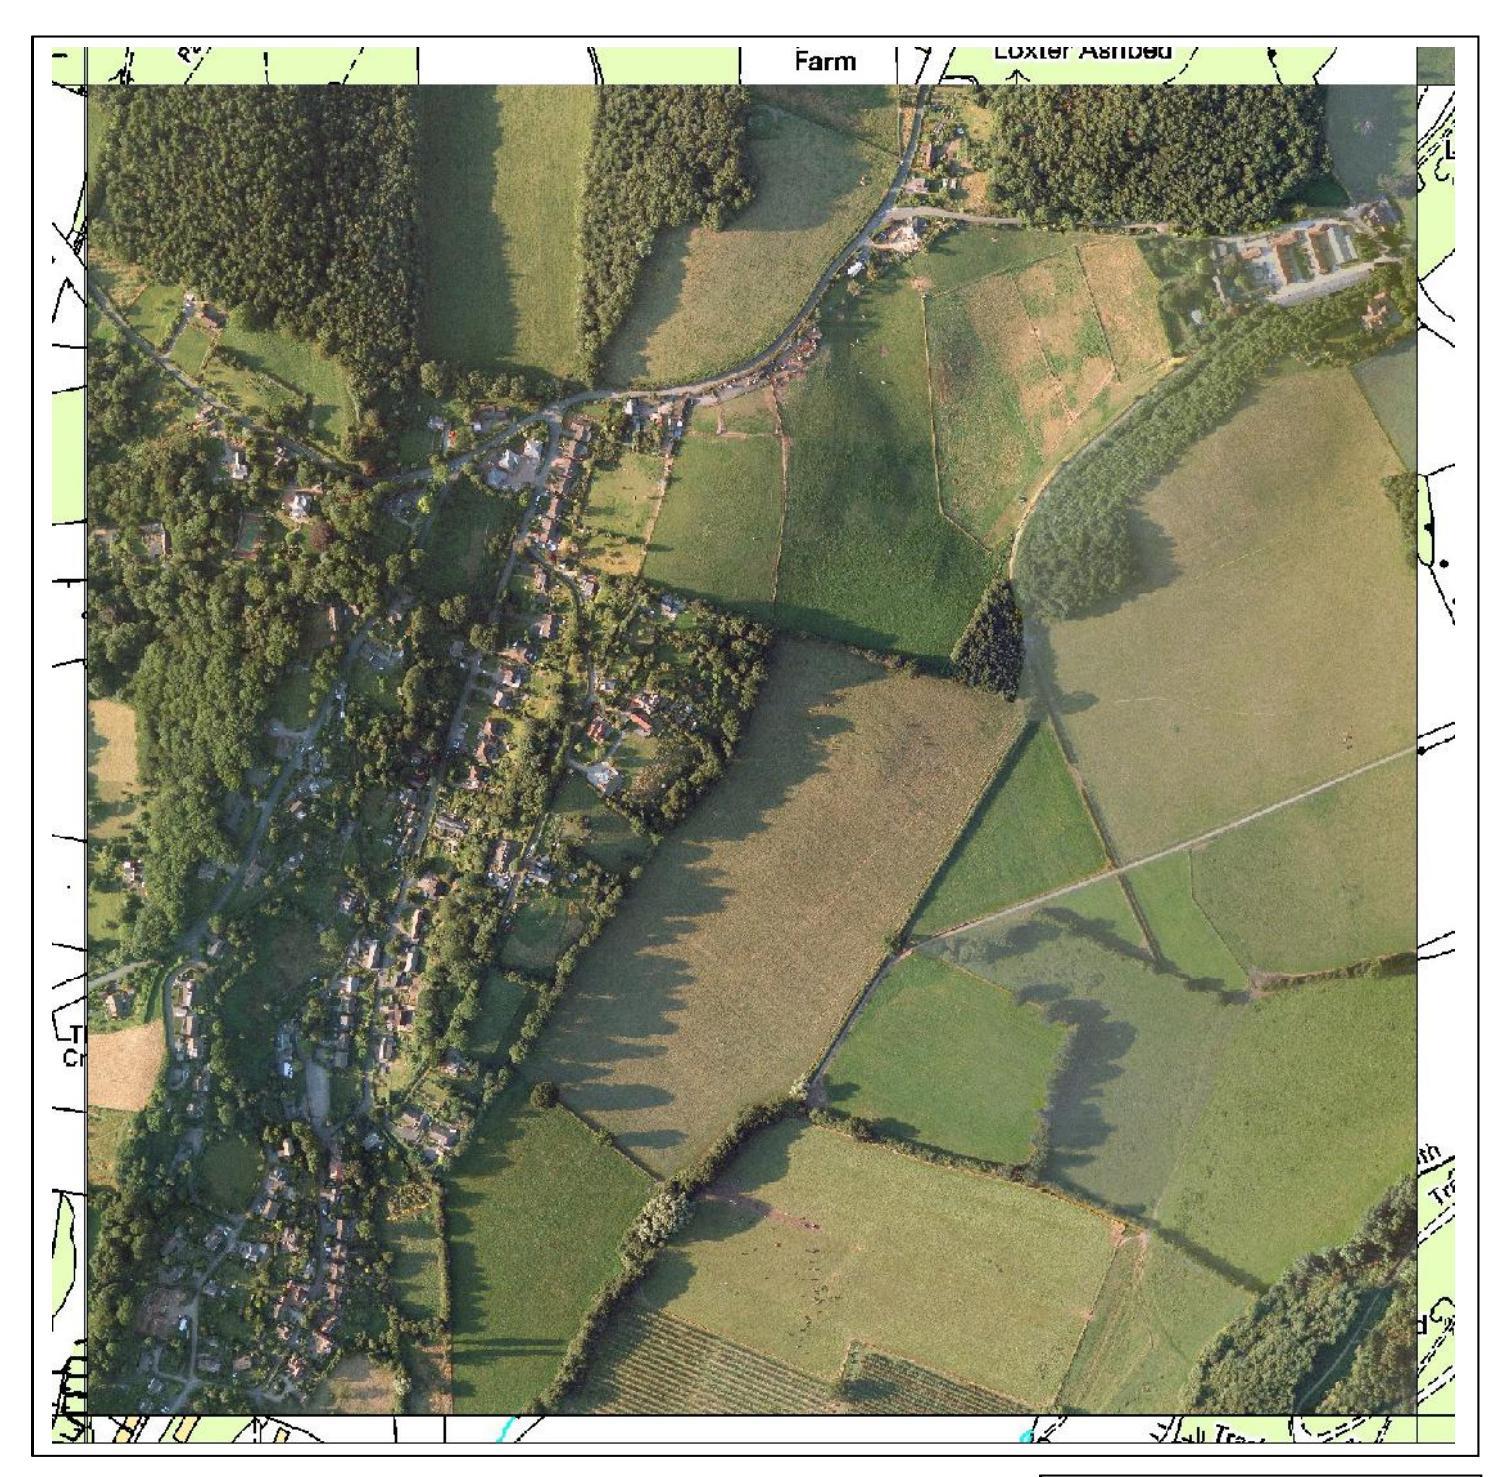
Figure 6. Wellington Heath south Survey Square with aerial photograph overlaid on OS mapping

Summary of Landscape Character, Historic Landscape Character and Landscape Sensitivity (refer to Annex 1)	Summary of actual observations in survey square	
Tree cover mainly confined to scattered (densely in places) hedgerow trees although there is an ongoing loss of these and many of those remaining are mature or veteran	Several hedgerows were tall and over mature but isolated hedgerow trees were rare. Overall the tree cover was divided fairly equally between woodland and hedgerow. No veteran trees were found within this grid square.	
Original assarted pattern of woodland clearance overlaid with a piecemeal grid enclosure	Large blocks of woodland remain in this area and the old woodland edges can still be identified through the hedgerow pattern. The farmland in- between shows a strong sub-regular piecemeal grid enclosure and also a later, more modern and more regular grid enclosure.	
Boundaries are generally in good condition but there is some progressive loss and degradation of hedges in places. Some loss of hedges has increased field size. Hedgerows often tall and over mature.	Some fields have been amalgamated and fences inserted to create horse paddocks. Some hedgerows in less than perfect condition due to livestock damage. Several hedgerows were tall and over mature.

Guidelines for the enhancement and protection of hedgerows within the Principal Wooded Hills, Settled Farmlands on River Terraces and Forest Smallholdings and Dwellings Landscape Types that are of particular relevance in this grid square are to:

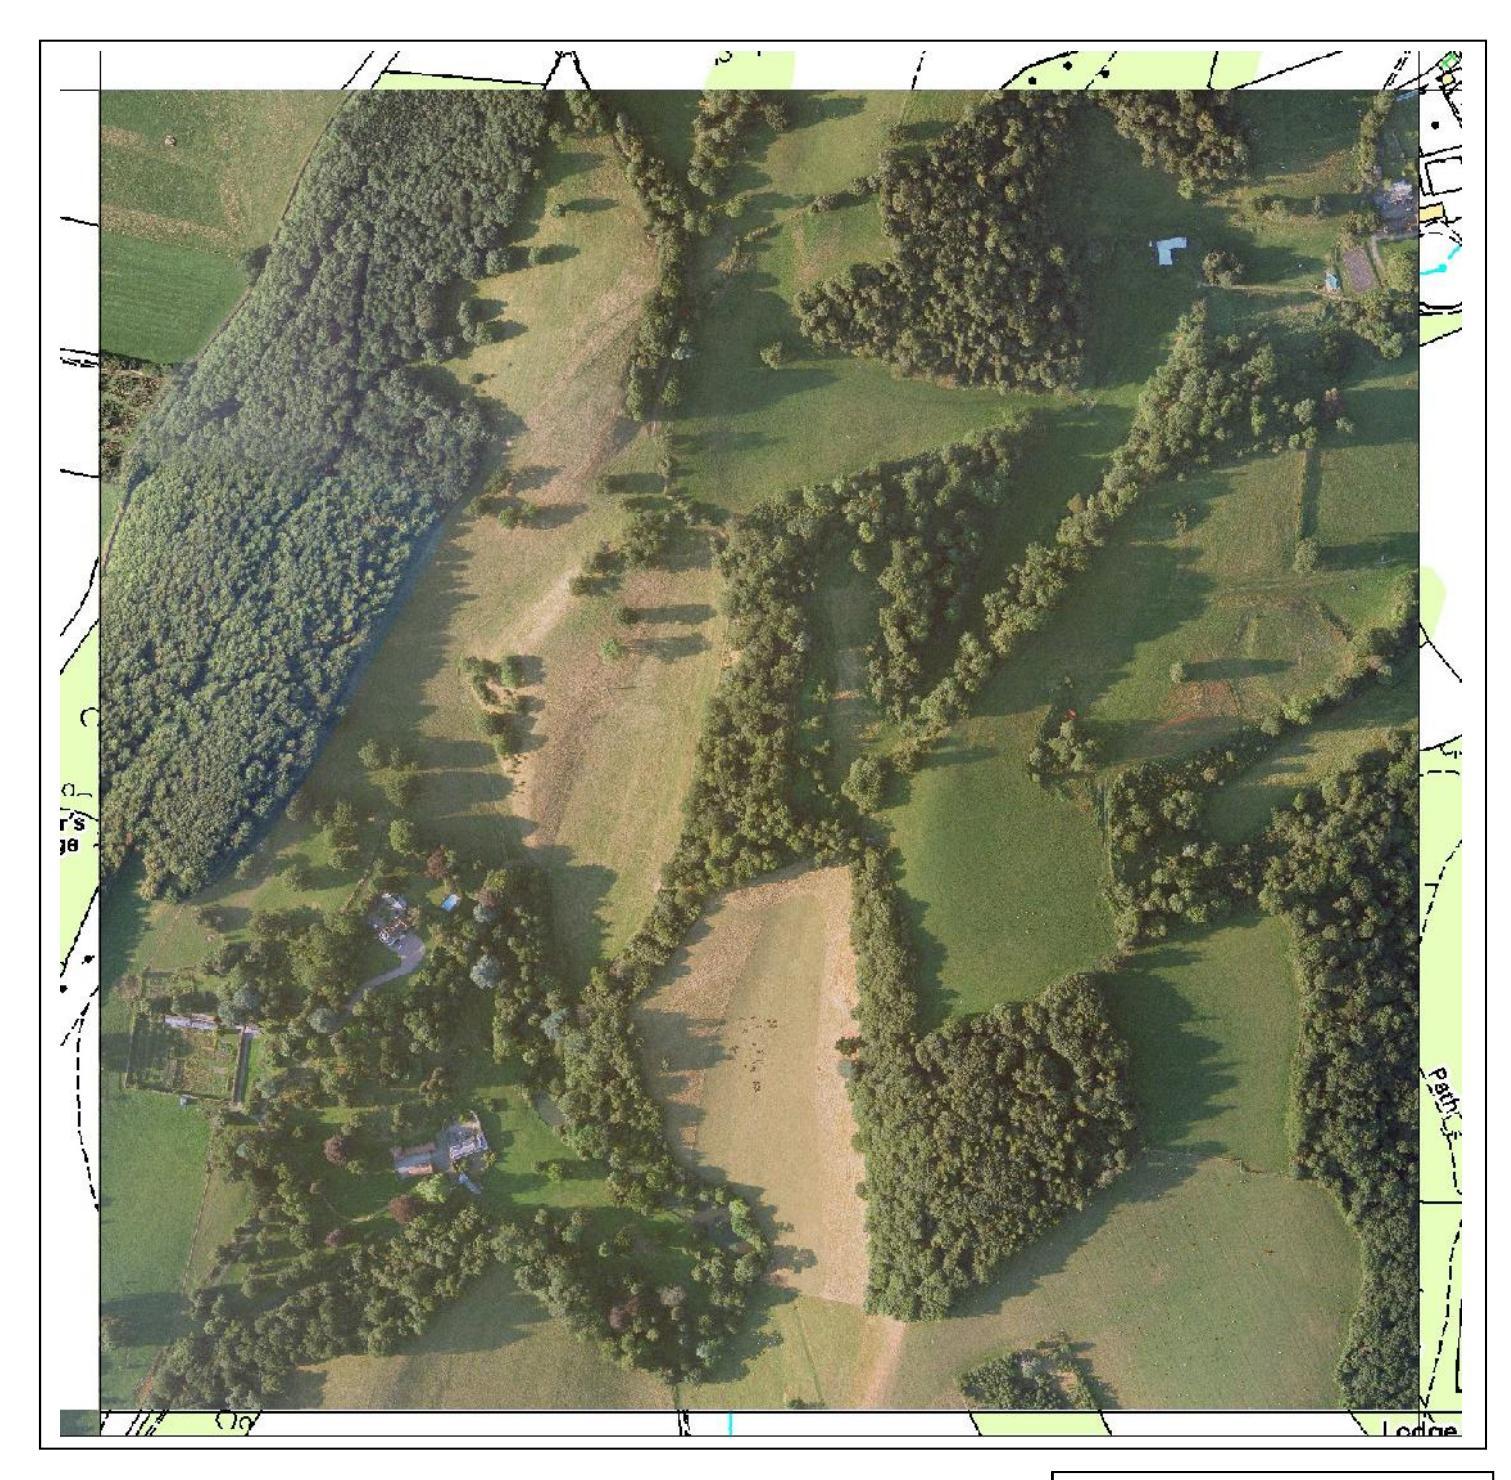
Figure 7. Wellington Heath north Survey Square with aerial photograph overlaid on OS mapping

Summary of Landscape Character, Historic Landscape Character and Landscape Sensitivity (refer to Annex 1)	Summary of actual observations in survey square
Assarted pattern of woodland clearance overlaid with piecemeal enclosure pattern	The survey area is dominated by assarted fields and medium sized, interconnected blocks of ancient woodland. Evidence of the past enclosure of strip fields can still be seen in several places in the form of low earthworks and changes in ground vegetation although the boundaries are now gone. A small area in the north west corner of the survey square falls outside the registered parkland and here we move to a larger scale pastoral landscape with hedged fields and little woodland.
Wooded streamlines and hedged fields	Not at all evident in the majority of this grid square. The small area in the north west corner does conform to this character.
Significant loss of hedgerow trees with those present often mature or veteran	Hedgerows are not characteristic of this particular grid square. Trees of interest are old parkland or woodland edge trees.

Poor hedgerow condition	The single hedgerow surveyed was leggy with an average mix of species. Ground flora showed the hedgerow's woodland origins (dog's mercury).

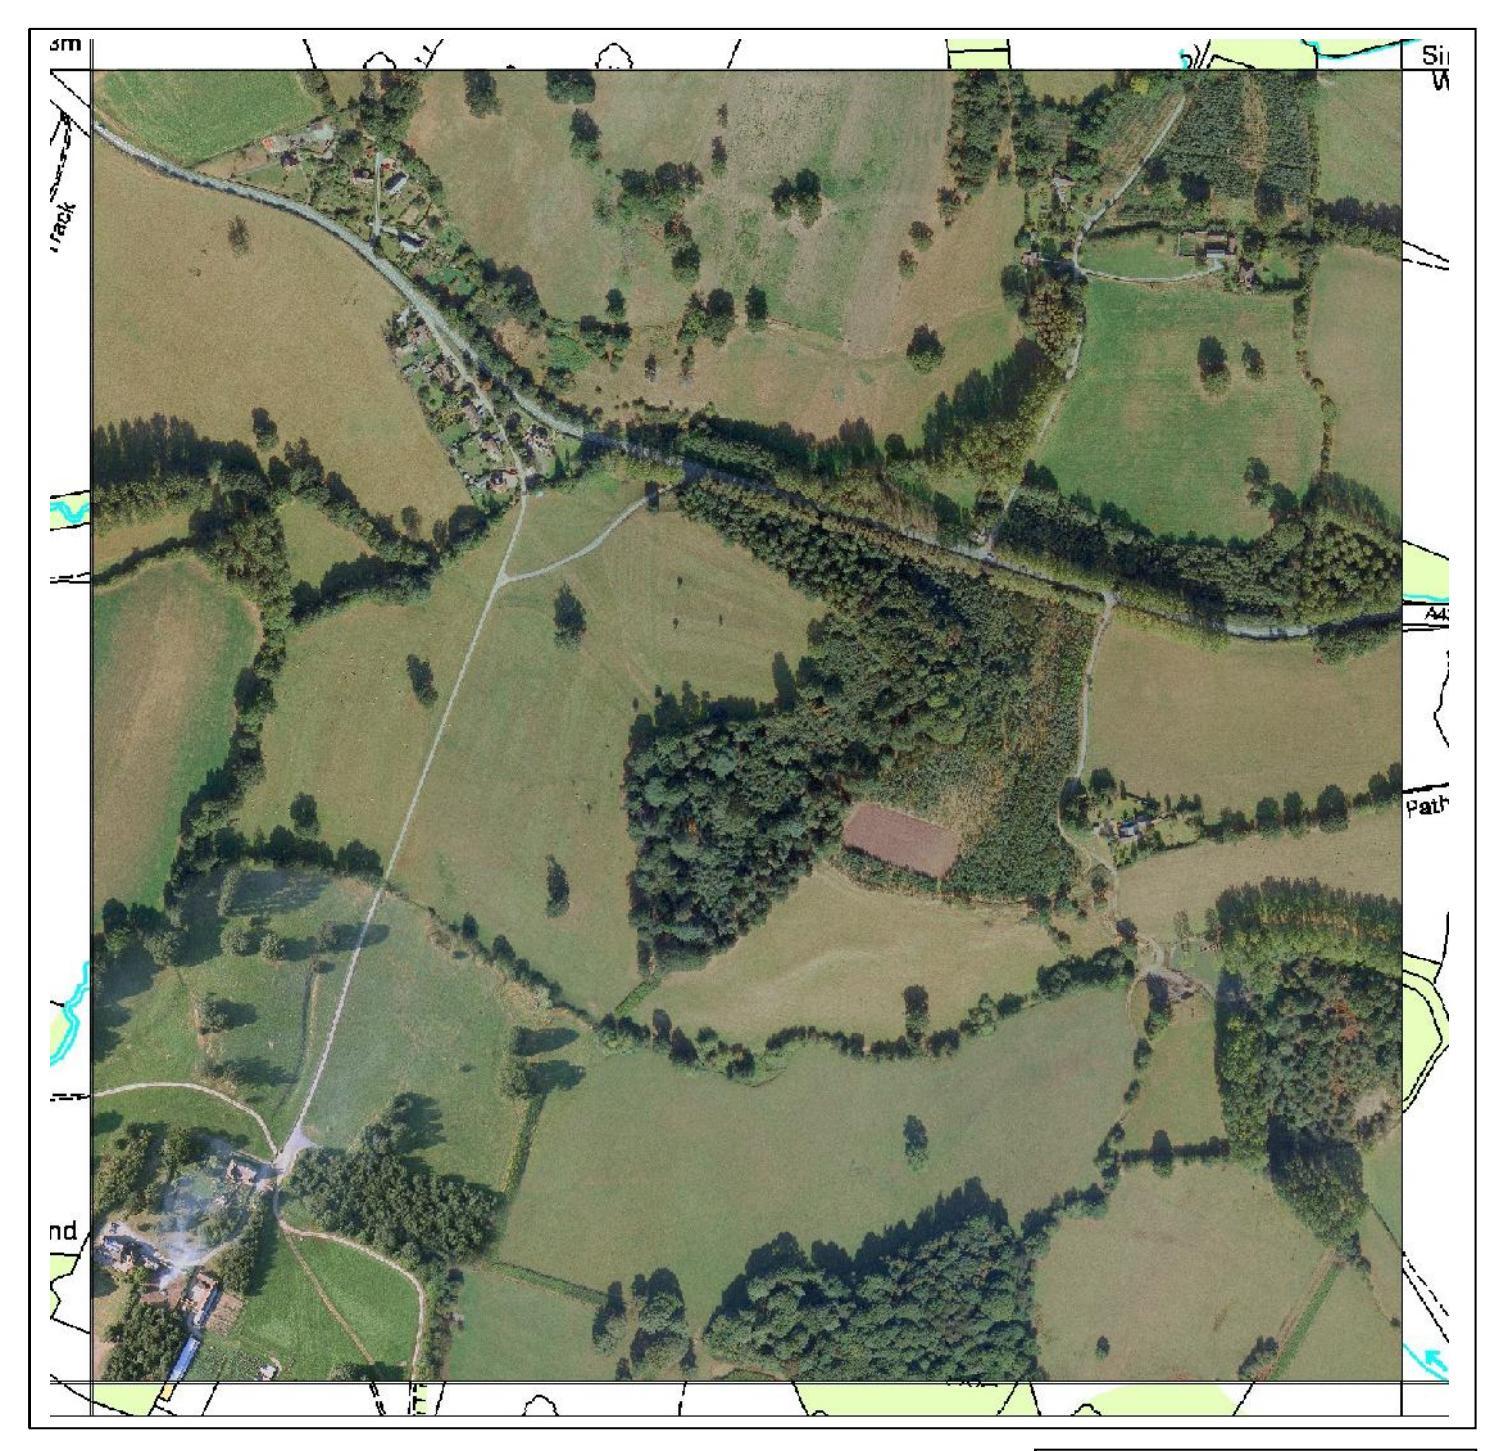
Figure 8. Eastnor Survey Square with aerial photograph overlaid on OS mapping

Summary of Landscape Character, Historic Landscape Character and Landscape Sensitivity (refer to Annex 1)	Summary of actual observations in survey square	
Large hedged fields with hedgerows linking woodland blocks	Fields hugely variable in size. Hedgerow and streamside trees link woodland blocks but the corridors are very narrow.	
Loss of previous field enclosure pattern	Sinuous boundaries still very evident but the landscape is now much more open and the small scale enclosure character lost. Woodland blocks have shrunk or disappeared and the character of this grid square is now strongly influenced by the parkland landscape imposed on top.	
Declining hedgerow condition with some introduction of fences. Significant loss of hedgerows in some areas.	Several hedgerows had grown out and some were significantly leggy and gappy exacerbated by stock damage. Some hedgerow boundaries have been replaced by fences.

Some loss of hedgerow trees (significant in places)	Isolated hedgerow trees were not characteristic of this survey square although several hedgerows had grown tall and over mature and now existed as lines of trees. Occasional isolated trees were present as in-field trees or remnant parkland trees.

Guidelines for the enhancement and protection of hedgerows within the Wooded Hills and Farmlands Landscape Type that are of particular relevance in this grid square are to:

- Maintain the condition and integrity of strong, sinuous hedgerows linking woodland blocks
- Focus on restoring hedgerows that have become gappy and leggy and maintaining any associated stone facing banks
- Discourage insertion of fenced boundaries

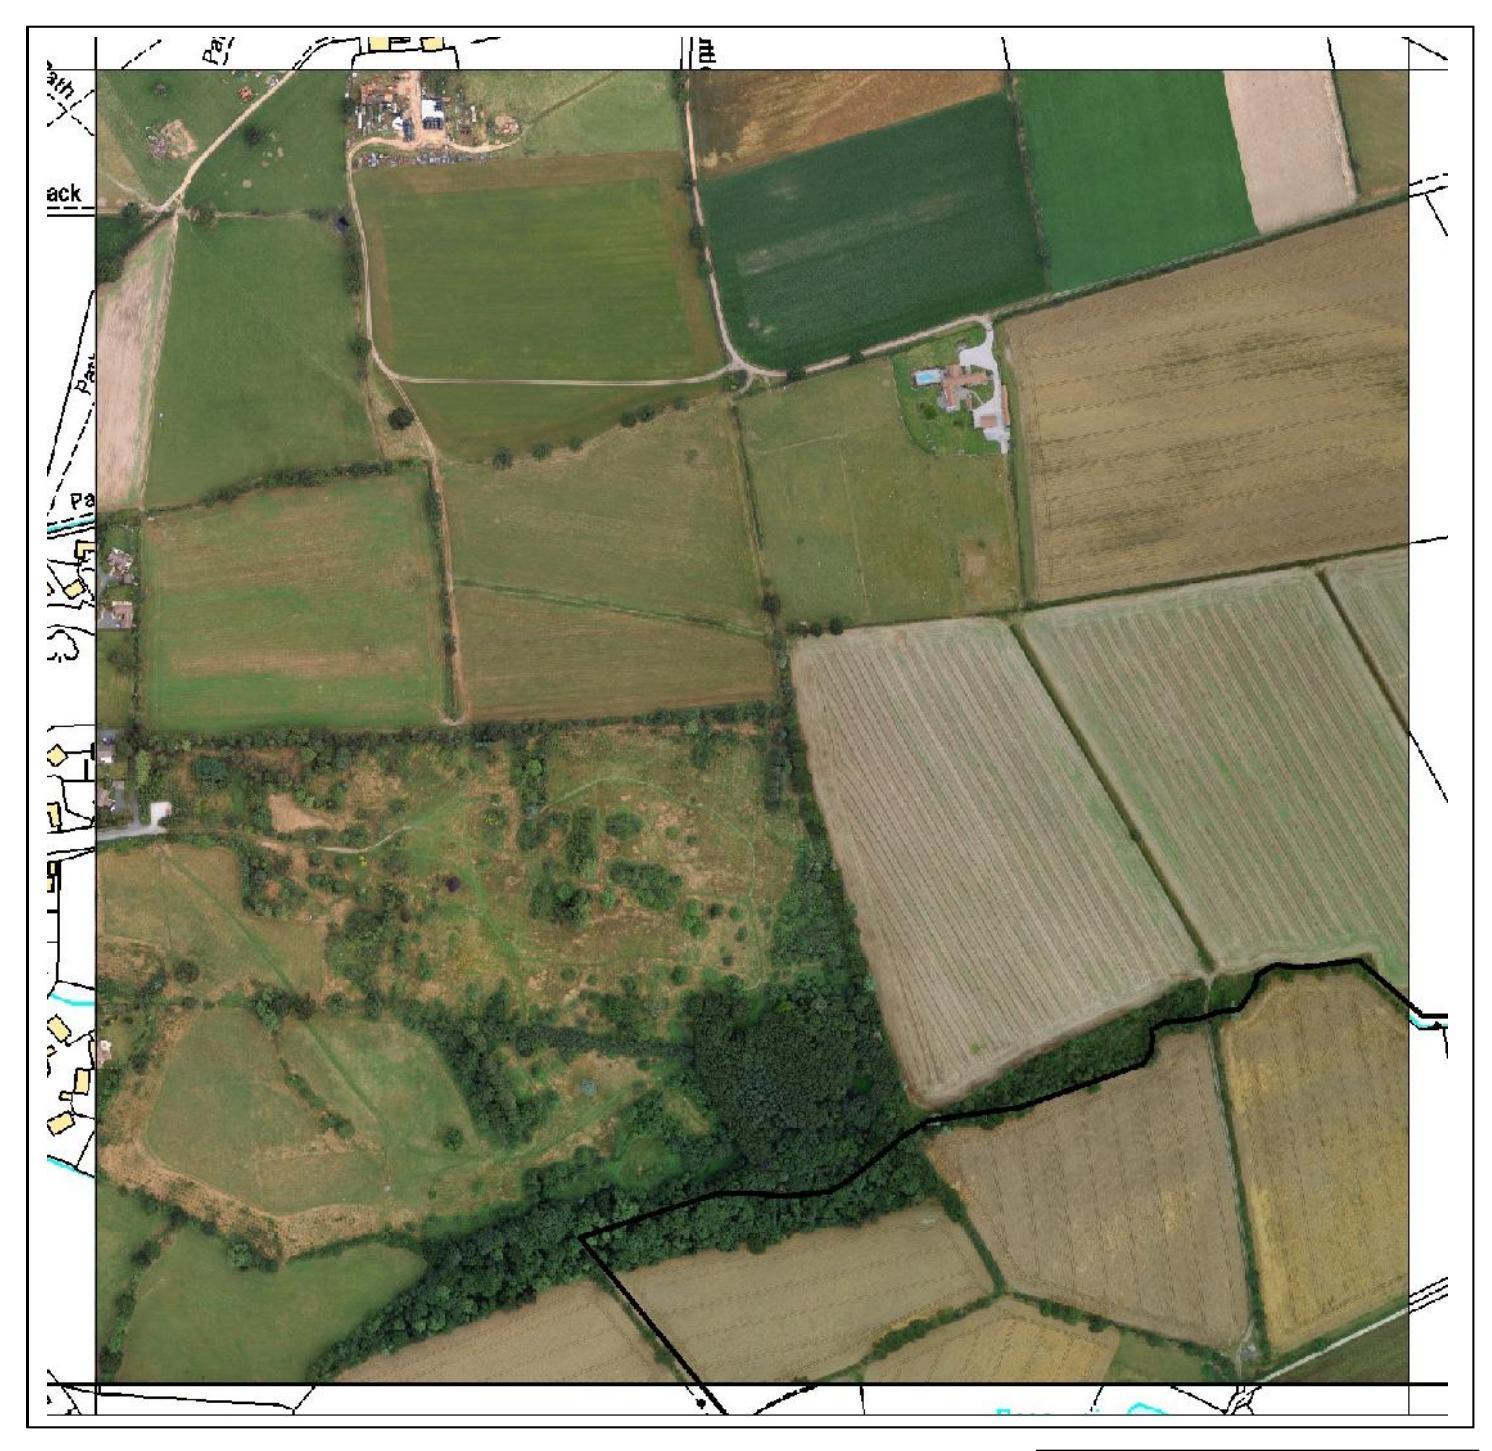
Figure 9. St Wulstans Survey Square with aerial photograph overlaid on OS mapping

Summary of Landscape Character, Historic Landscape Character and Landscape Sensitivity (refer to Annex 1)	Summary of actual observations in survey square	
Geometric, large-scale, late enclosure field pattern becoming fragmented in places	Medium-large scale geometric pattern broken up by the presence of St Wulstans nature reserve in the south west corner of the grid square.	
Generally unmanaged thorn hedges with some loss. Some hedgerows becoming fragmented and gappy due to increasing arable land use.	Hawthorn and blackthorn were the most frequently occuring and dominant species. Some hedgerows were composed almost entirely of one or both of these. Hedgerows were often gappy, sometimes to the point of complete loss. Land use was predominently arable.	
Some garden hedge and fence intrusion and some sub-division of fields with fences in places	Very occasional sub-division with fencing in sheep pastures.

Thinly scattered hedgerow trees	Isolated hedgerow trees were a very occasional feature.

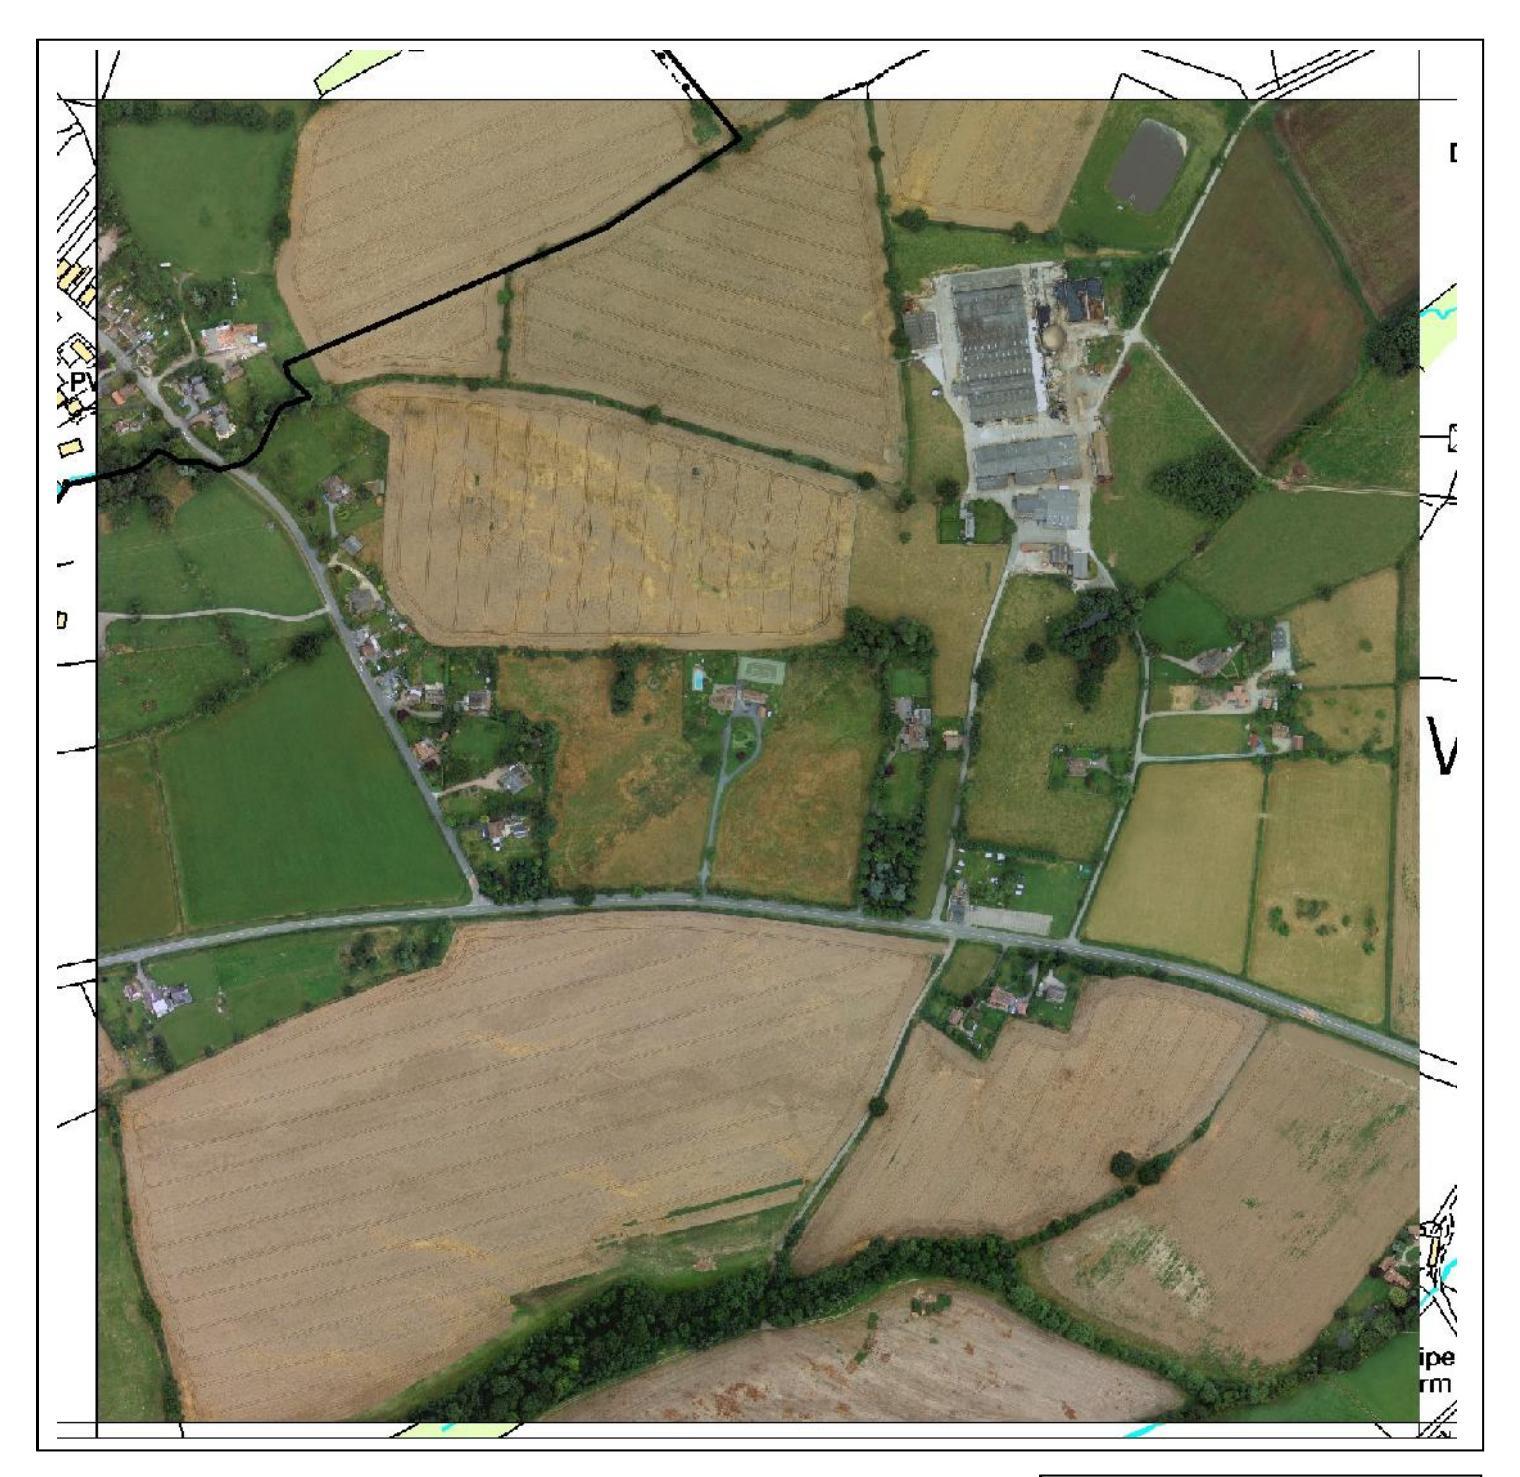
Figure 10. Welland Survey Square with aerial photograph overlaid on OS mapping

Summary of Landscape Character, Historic Landscape Character and Landscape Sensitivity (refer to Annex 1)	Summary of actual observations in survey square	
Geometric pattern of large, late enclosure pastoral fields with pattern becoming fragmented	Sub-regular pattern with fields varying hugely in size. Some amalgamation has taken place. Arable farming dominates broken up with areas of pasture.	
Regularly and intensively managed thorn hedges in deteriorating condition and becoming gappy. Loss is high in some areas. Elm is also prominent in the hedgerows.	Hawthorn and dog rose were the most frequently occuring species, found in 9 and 7 respectively of the hedgerows surveyed. Elm was found in only one hedgerow but it was the dominant species there. Blackthorn was also frequent, found in 6 hedgerows and often the dominant species. Hedgerows in the square were divided between those neglected and over mature and those managed intensively. Some hedgerows were gappy and occasionally replaced entirely by fencing.

Encroachment of fenced gardens occurs in some places with some fields also broken up by fencing additions.	This influence was not noted on those hedgerows selected for survey. Sycamore and garden privet were recorded in one roadside hedge.	
Thinly scattered hedgerow trees	Many hedgerows were tall and over mature, both alongside and away from watercourses. Some hedgerows in the north of the survey area had scattered isolated hedgerow trees. Hedgerow pollards were an occasional feature in the south east of the grid square.	
Some sub-division of fields with fences	No sub-division was noted during the survey.

- Restore the integrity of the hedgerows where they are becoming gappy due to neglect in arable areas
- Maintain the varied field scale characteristic of this area, whilst guarding against further hedgerow loss through field amalgamation
- Discourage the replacement of hedgerows with fences

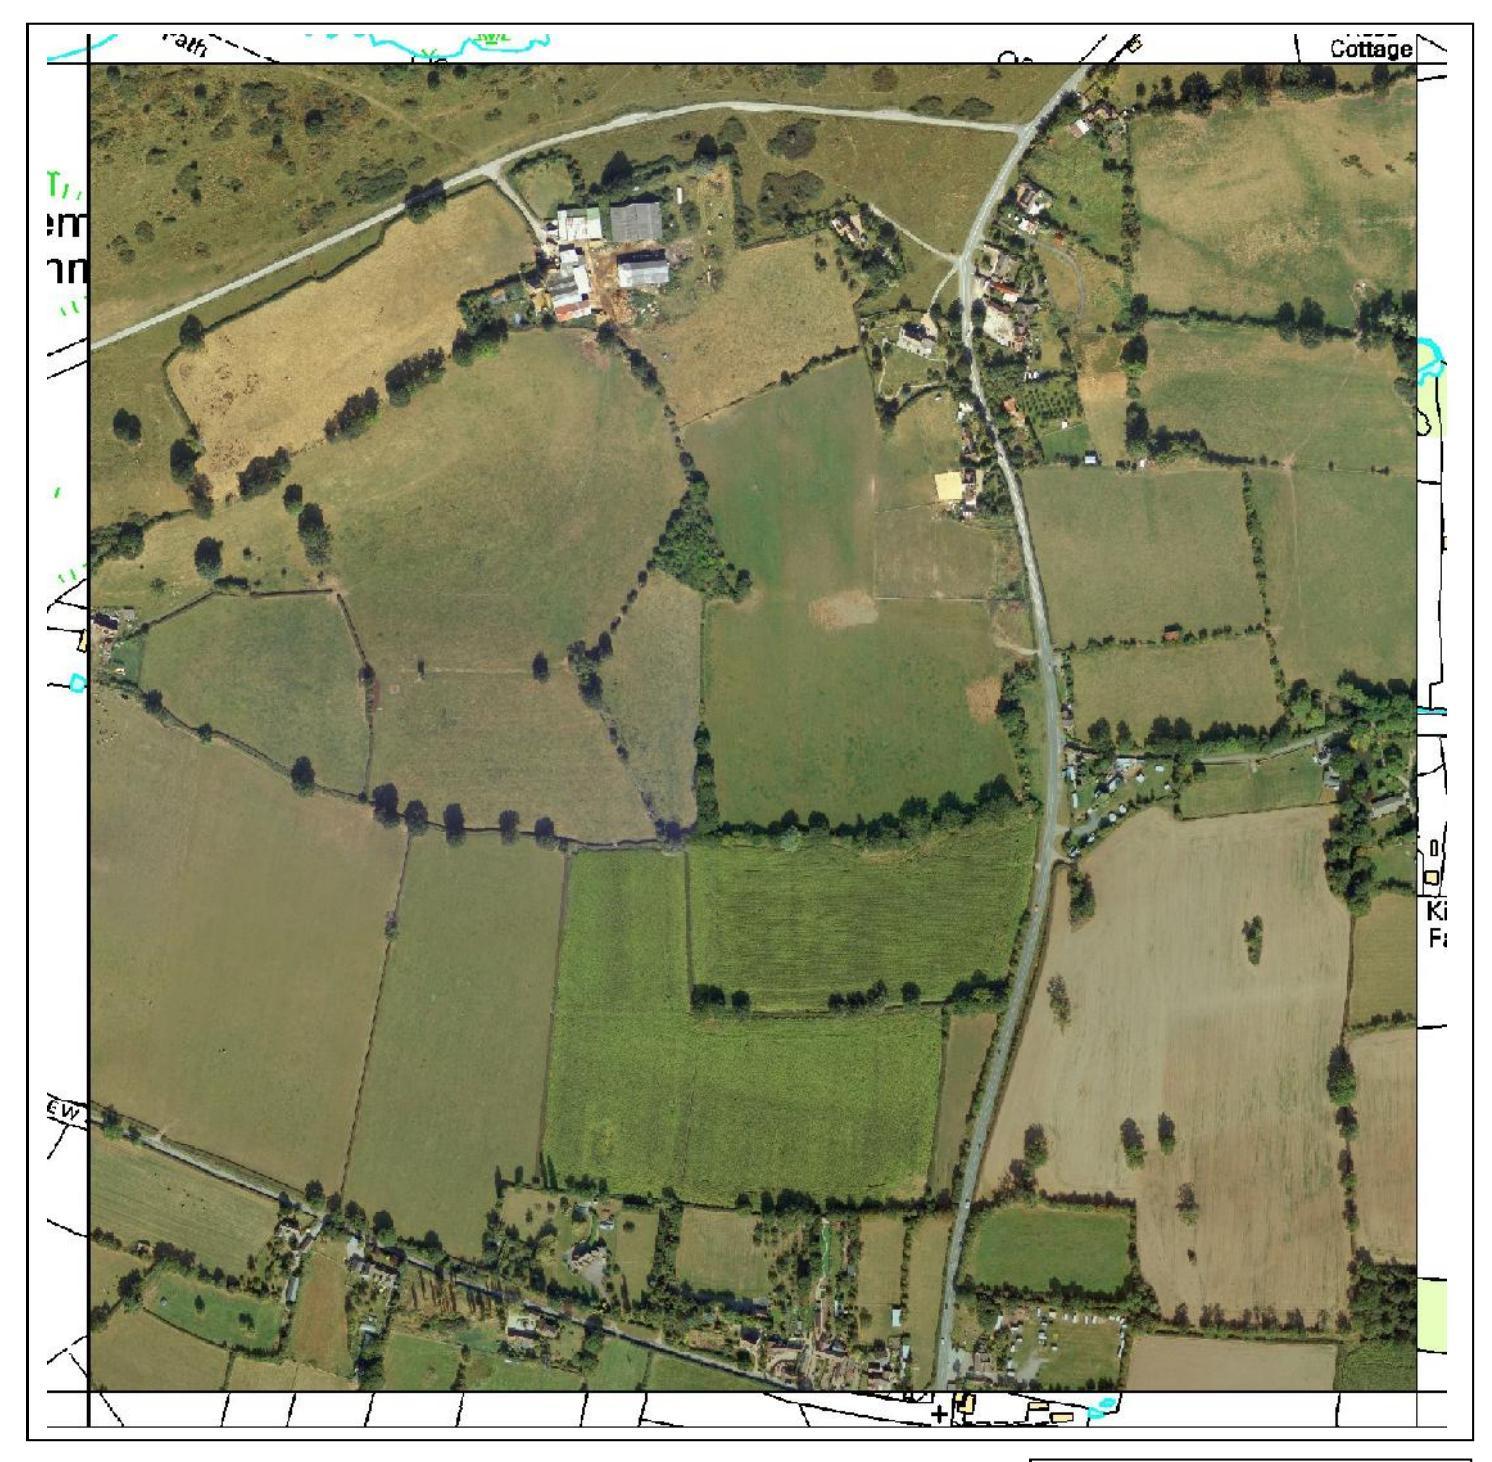
Figure 11. Castlemorton Survey Square with aerial photograph overlaid on OS mapping

Summary of Landscape Character, Historic Landscape Character and Landscape Sensitivity (refer to Annex 1)	Summary of actual observations in survey square	
Settlement around the perimeter of the common leads to a loss of unenclosed character through the intrusion of hedges and fences around paddocks and gardens. Away from the common there is a small to medium scale sub-regular pattern of pasture fields (and increasing arable land use) associated with settlement	Hedgerows semi-regular away from the common; more sinuous along the common edge due to encroachment enclosure pattern. Sub-regular medium scale field pattern seen away from the unenclosed common with some amalgamation. Settlement is dispersed along the road sides and is not yet at a scale that detracts from the landscape character.	
Hedgerows sometime managed, sometimes neglected with some loss or removal. Elm found in hedgerows.	Only one hedgerow was found to contain elm and in a very small quantity. Occasionally hedgerows were neglected and either gappy or tall and mature but most were managed.

Occasional fencing additions	Limited fencing additions.	
Thinly scattered hedgerow and streamside trees with some localised loss and sometimes in poor condition	Frequent hedgerow trees including many old pollards. Most of these were in reasonable condition although management had long since lapsed.
