# Farming in Protected Landscapes (FiPL)

## Guidance notes for Historic Buildings restoration and repair

October 2023

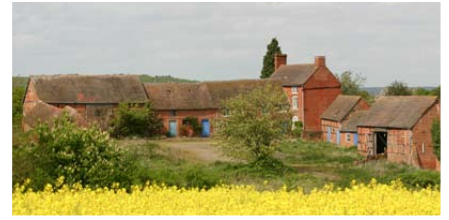
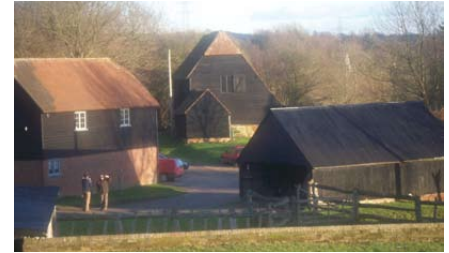
**Vernacular buildings** are characteristic of their locality, rather than following national models or being designed by architects, agents or engineers. They often use locally available materials, although they may include the use of imported brick, slate and other materials as these became available in the area. They will often display evidence for successive change, with farmsteads and buildings developing and being added to over time.

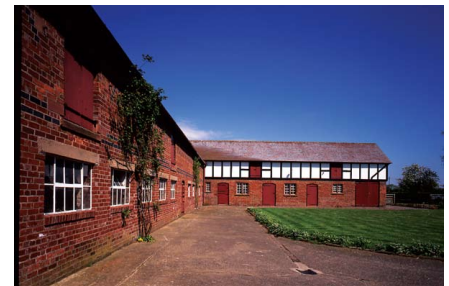
**Designed buildings** usually form part of regular-plan late 18th/19th century groups based on national models, and more commonly result from the building programmes of estates than individual farmers. The groups are usually built in a single phase, sometimes in a recognisable architectural style, and are usually marked by a consistent use of local or imported materials.

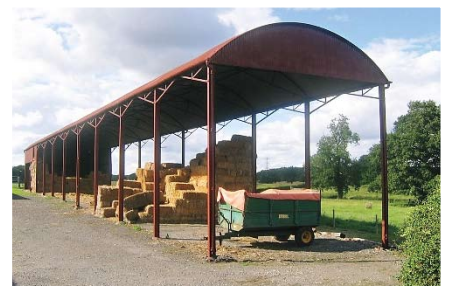
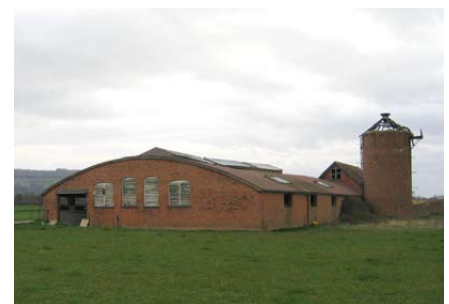
**Industrially-produced buildings** comprise factory-made prefabricated structures using steel/iron frames and corrugated iron cladding (eg Dutch barns as used from the later 19th century and examples of 1914-40 concrete and industrial brick structures (eg silage towers) and groups).

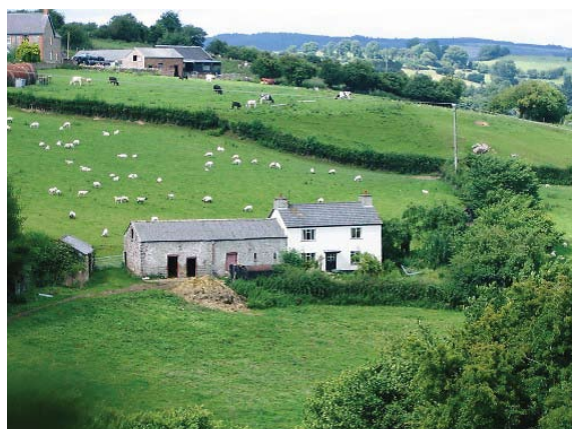
**Linear plans** where houses and working buildings are attached and in-line, and which are now most common in northern and western pastoral areas.

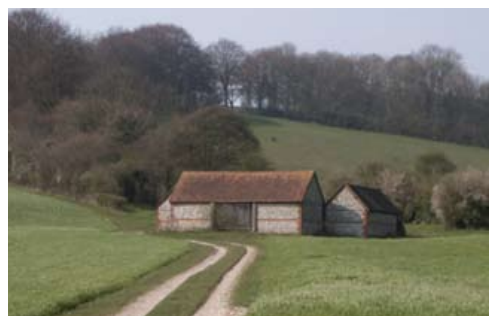
**Field barns** and **outfarms**, which are detached from the main group. These may have been built with yards, and been provided with access tracks.

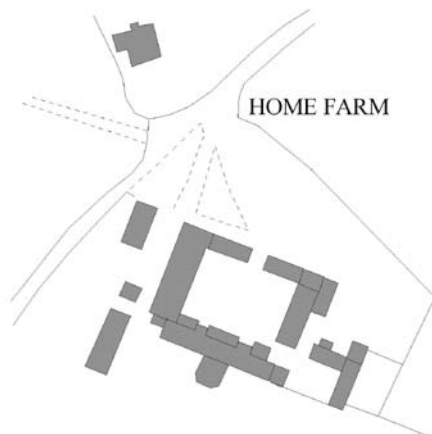
**Substantially intact** – farmstead is largely unaltered from its traditional form

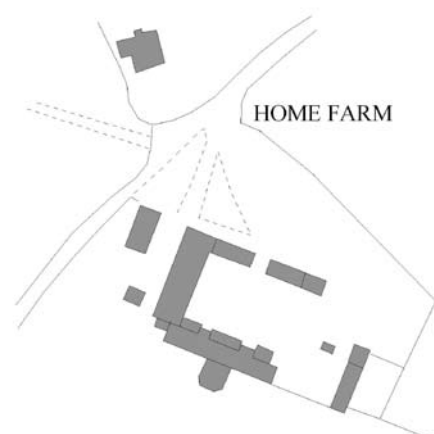
**Partial Loss** – less than 50% loss of buildings

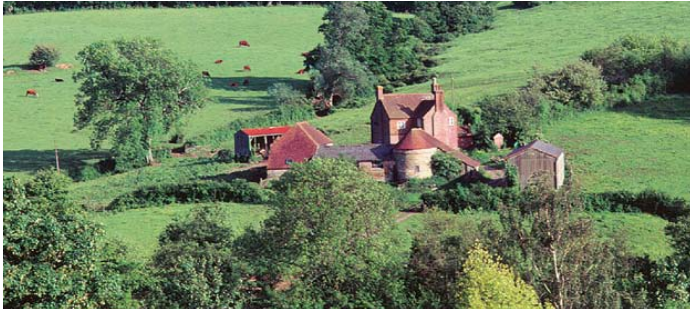
- sited among small-scale and irregular fields, which can result from land and woodland clearance in the medieval period or earlier:

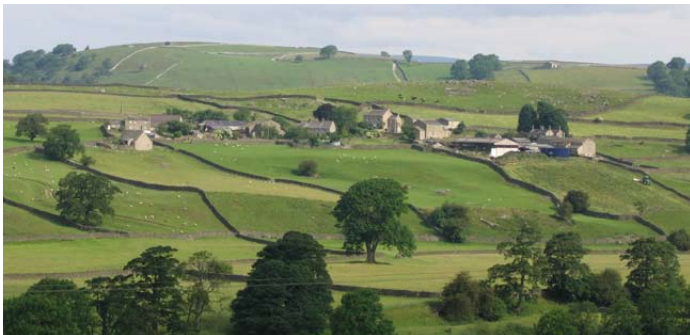
- sited amongst piecemeal patterns of enclosure, which may date from the medieval period.

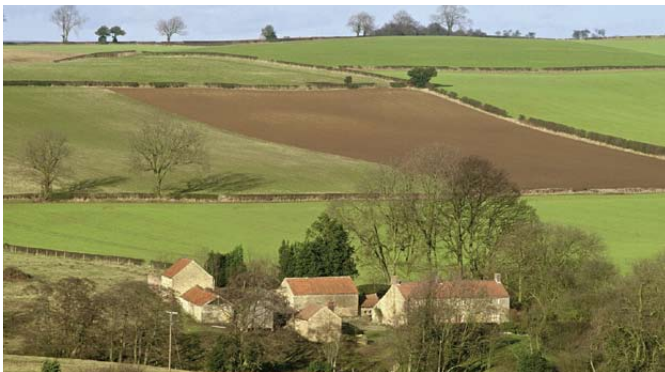
- sited amongst regular patterns of enclosure, which are most commonly associated with the period after 1750 and the replanning of common land or earlier enclosed landscapes, sometimes with new farmstead sites.
